**MEMO**

On Wednesday, September 21, 2016, seven archaeologists from the State Historical Society of North Dakota (SHSND) conducted a pedestrian inventory (cultural resources survey) of the 1.36 mile long Dakota Access Pipeline (DAPL) project construction corridor in Morton County west of North Dakota Highway 1806 under considered review, at the request of the joint Law Enforcement Task Force formed to investigate the DAPL project (see Figure 1 attached).

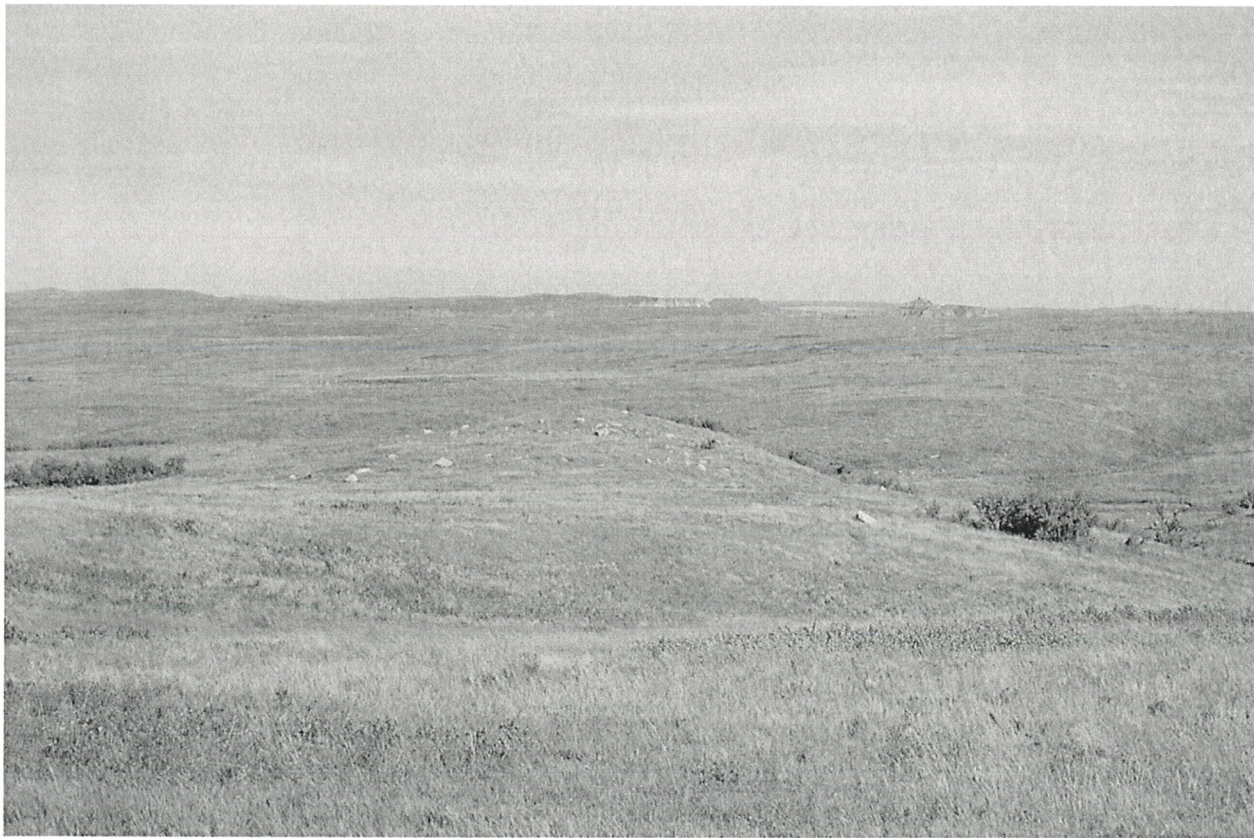
Figure 2. Photograph of glacial erratics exposed on hilltops adjacent to the inventory area.

The survey corridor environs comprised rolling upland prairie grasslands west of the Missouri River bisected by shallow ephemeral drainages. Glacial erratics (bowling ball to car sized) were exposed on hilltops and side slopes along the length of the survey corridor project area (see Figures 2-3 attached).

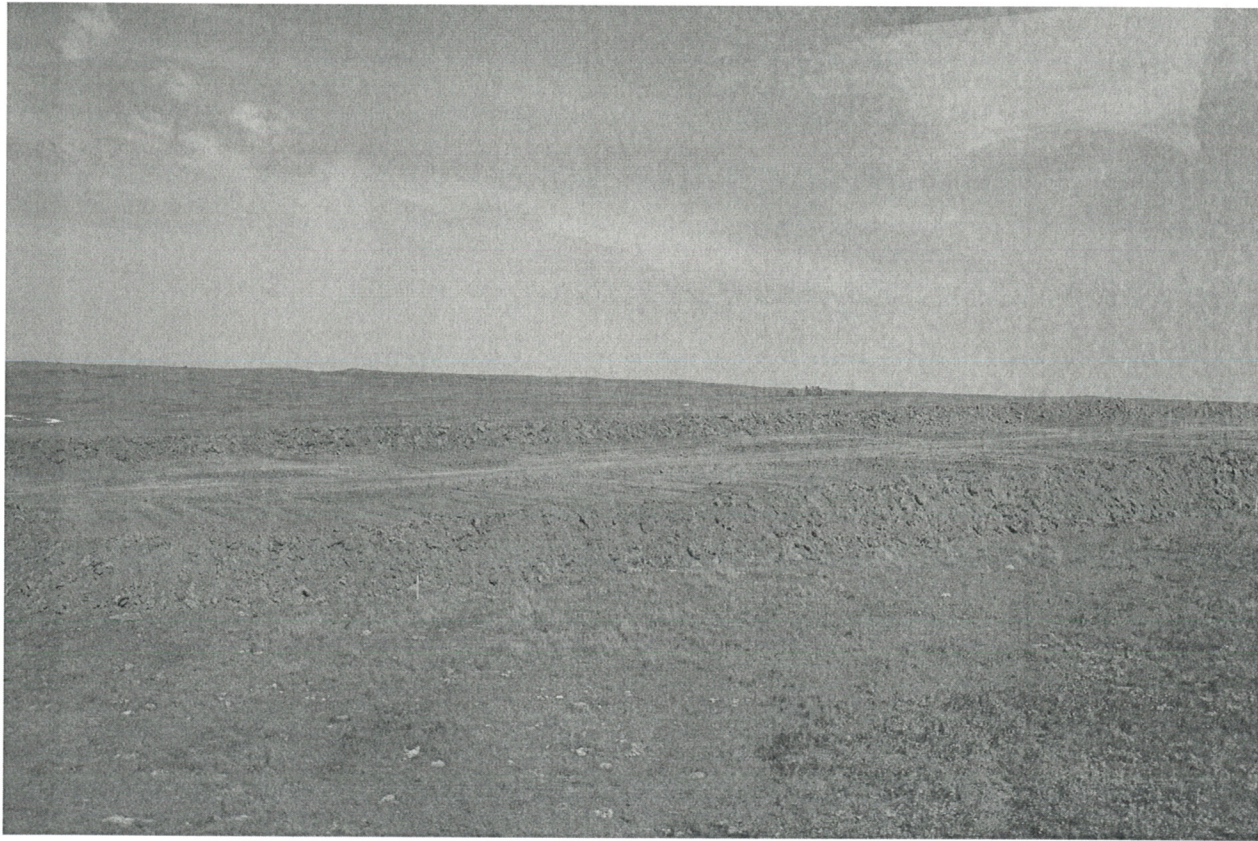
Figure 4. Photograph of the Dakota Access Pipeline construction corridor inventory area showing stripped surface and stockpiled topsoil berms along the lateral margins.

The DAPL construction corridor had been stripped with topsoil stockpiled along the lateral margins (see Figure 4 attached). SHSND archaeologists traversed the corridor at seven-meter interval spacing inspecting the stripped ground surface and both sides of the two opposing stockpiled topsoil berms along the lateral margins of the corridor.
